Fire Risk Assessment

Project 1535

The Croft Preparatory School

Revision 0.1

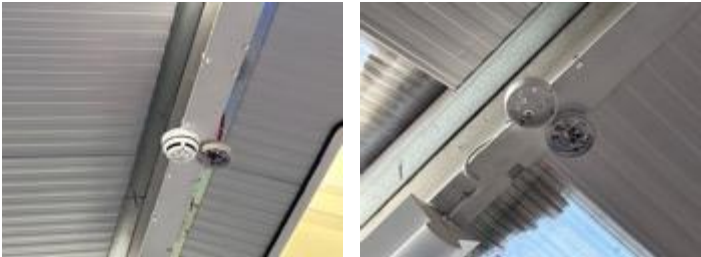
2	B	
9.	<p>It is recommended that the fire alarm system is reviewed by a competent fire detection and alarm system designer as several deficiencies were observed, including;</p> <ul style="list-style-type: none"> ■ Detection required in Little Crofters nursery kitchen, within Theatre kitchen and within sports hall; ■ Detection design in Theatre inappropriate as not positioned in apex of roof; ■ Detectors appear to have been inexplicably removed from the stairway leading to the Estates Manager's apartment; ■ Detection in covered area 1 is inconsistent with covered area 2, within Little Crofters; ■ Obsolete manual call points need to be masked off, or removed, to avoid confusion.
